INTRAORAL REPAIR IN METAL-CERAMIC PROSTHESES: A CLINICAL REPORT.

REPARO INTRAORAL DE PRÓTESES METALO -CERÂMICAS : UM RELATO DE CASO CLÍNICO .

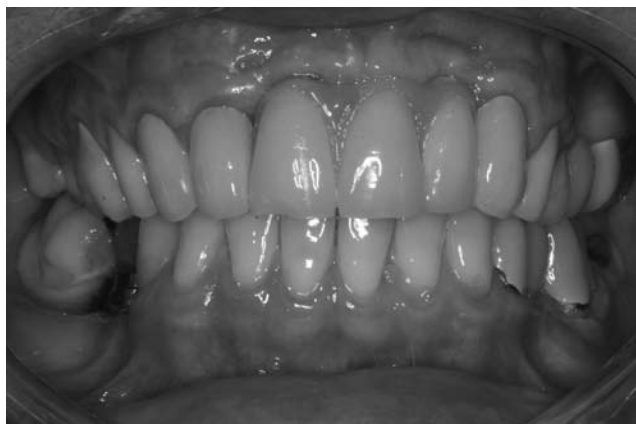
A 59-year-old woman was referred to the prosthodontic department in Araraquara Dental School, Sao Paulo State University [Faculdade de Odontologia de Araraquara] (UNESP) for treatment. Her main complaint was poor aesthetics due to a fractured fixed metalceramic prosthesis. According to the patient's report, a trauma caused the fracture. The clinical examination confirmed the presence of a fracture involving only the porcelain, in the incisal third of the labial surface of number tooth 11 of a 3-unit fixed partial prosthesis supported on implants number spanning teeth numbers Martinlinna *et al.*¹¹ 2006, 21 and 22 (Figure 1), fabricated three months earlier. Observe, in figure 1, the use of artificial gums on porcelain to correct the impaired aesthetics.

Fig. 1 – Frontal view of the clinical case.

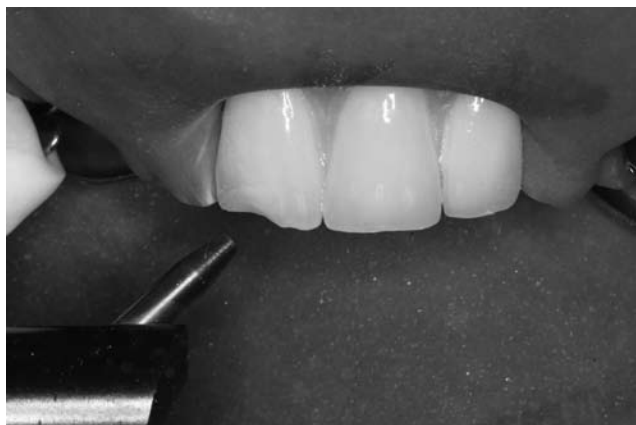
Fig. 2 – Airborn particle abrasion with 50um aluminum oxide.

- 1) The fractured surface was subjected to airborne particle abrasion with 50 µm aluminum oxide (Bio-art

Equip. Odontologicos Ltda, Sao Carlos – SP - Brazil) by means of a microjet (Bio-art Equip. Odontologicos Ltda, Sao Carlos – SP - Brazil) (Figure 2), and air-blown to remove the excess powder

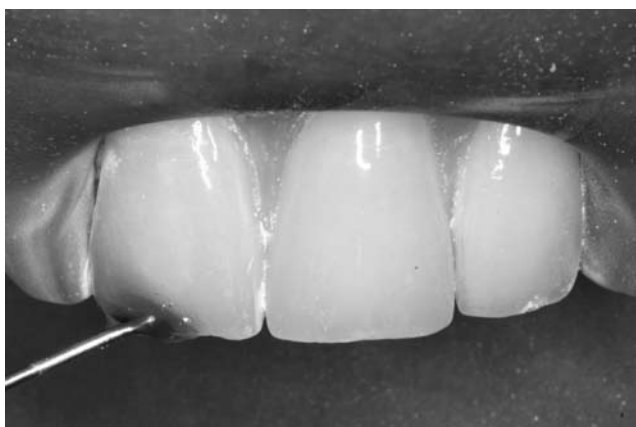
Fig. 3 – Etching with phosphoric acid at 37% for 15 seconds

2) Etching with phosphoric acid at 37% (3M ESPE, St. Paul – USA) for 15 seconds for surface cleaning (Figure 3)

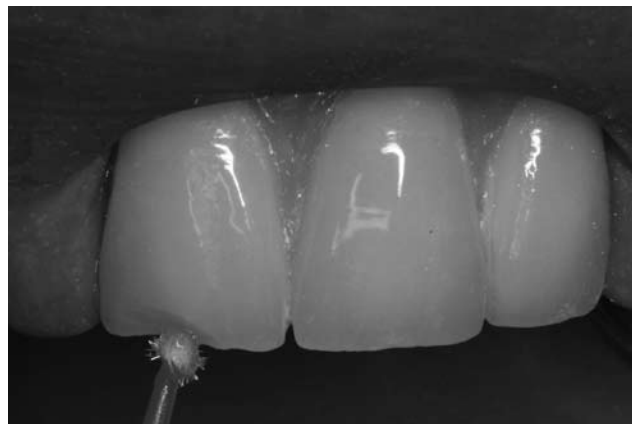
Fig. 4 – Application of the silane agent RelyX Ceramic Primer (3M ESPE)

4) Applied the silane RelyX® Ceramic Primer (3M ESPE, Seefeld -Germany), allowing 60 seconds for drying (Figure 4)

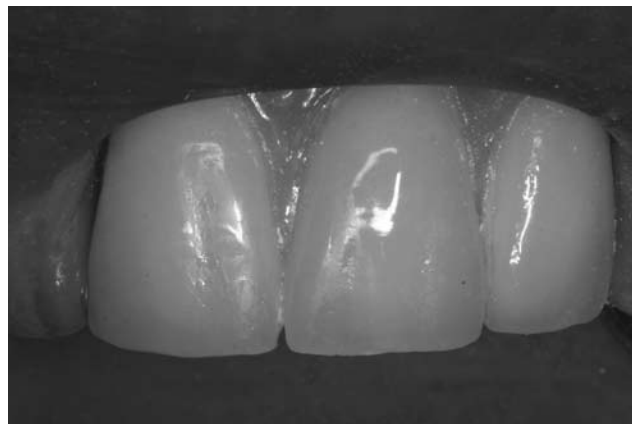
Fig. 5 – Applied composite resin Z100.

6) Applied the composite resin Z100 – Incisal Shade (3M ESPE, St. Paul - USA), incisal color, using an incremental technique (Figure 5)

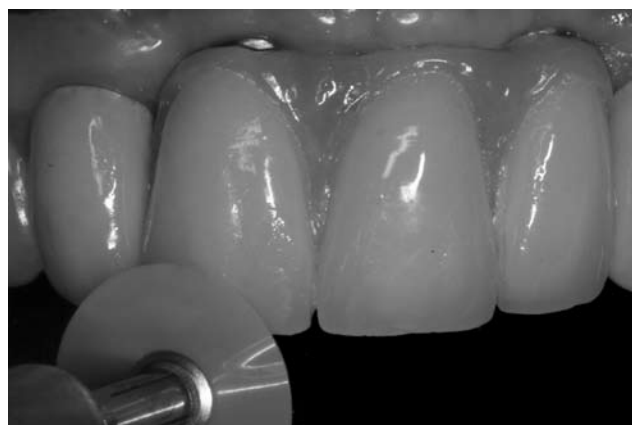
Fig. 6 – Use of the Soflex (3M) disk sequence for finishing and polishing.

After one week, the patient returned to the Dental School to carry out finishing and polishing procedures on the restoration (Figures 6 and 7). The final aspect of the restoration is illustrated in Figure 8.

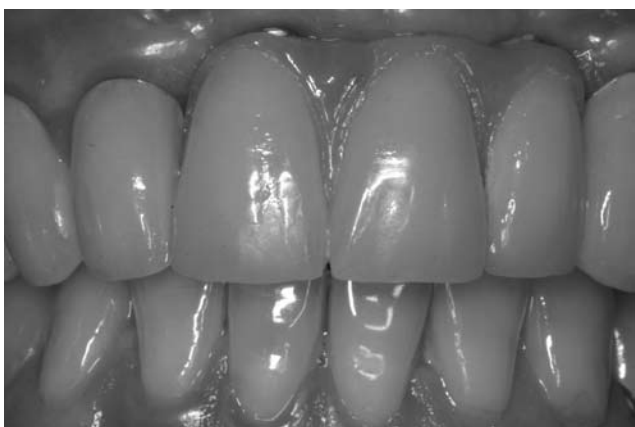
Fig. 8 – Final view of the intraoral repair
